PRODUCT NOTICE

PN-1513

MODEL(S): CRS8203, CRS620S, CRS620H Screen Plants
AFFECTED Specific PINs:

SUBJECT: Screen motor overload relay re-wire

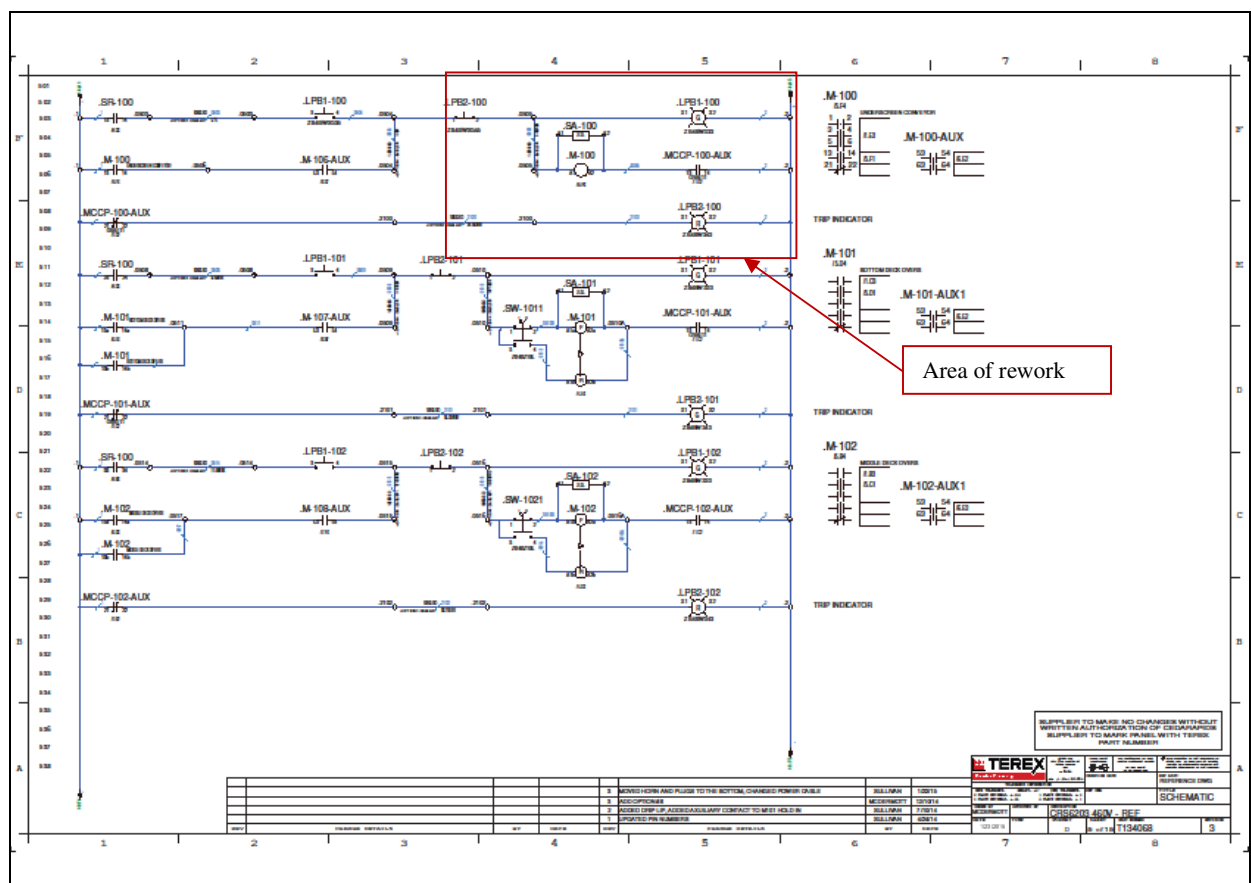
Terex has discovered a wiring issue in the screen motor overload relay circuit on the above noted machine PINs. The screen motor starter needs to be linked to the overload relay via the auxiliary circuit breaker rather than directly as it is now wired. This situation presents no problem in the normal, safe operation of the plant, but should be corrected to bring the machines up to the current electrical revision.

Original Schematic page 5 showing the area of the wiring rework.

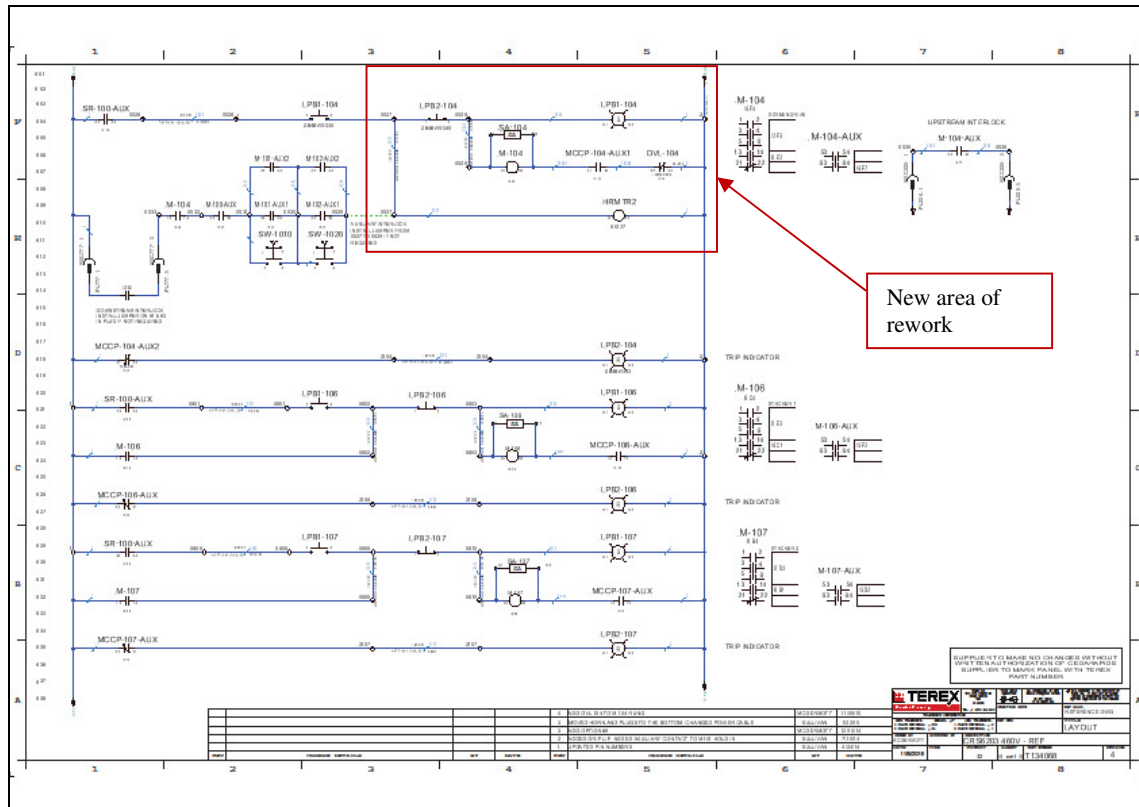
New Schematic showing the area of the wiring rework including Overload Relay 104.

These instructions are to install one new wire and replace an existing wire in the electrical panel. The rework will isolate the Overload Relay from directly starting the screen motor if the Overload Relay reset button is manually pushed while there is power to the electrical panel. The plant electrical schematic is factory supplied and can be found inside the panel door.

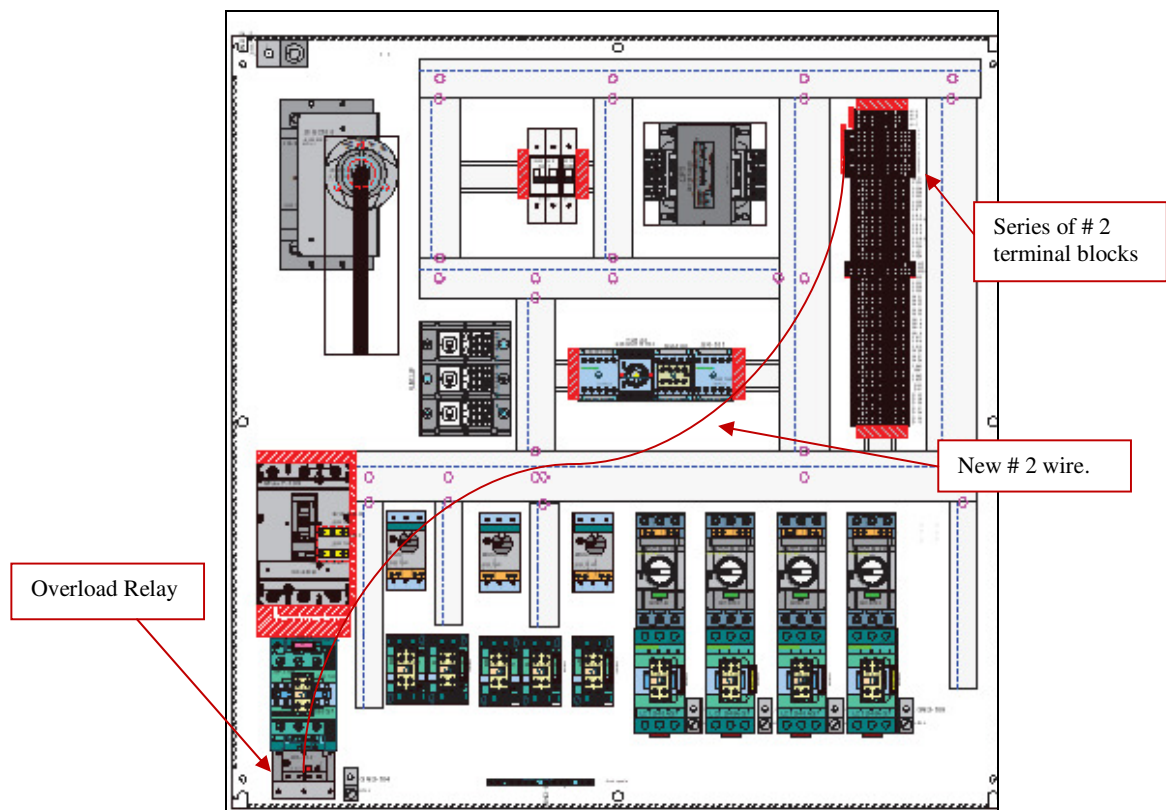
New # 2 wire from Pin 96 on the Overload Relay 104 to a # 2 terminal block.

3. Make a new # 2 wire (longer) to reach from pin 96 on Overload Relay 104 to a # 2 terminal block in the main panel terminal blocks
