# PARKER'S ELECTRICAL NQ

Gromac Quarry NQ

Barabon Quarry

This report is on the repairs made to all the plant at Barabon Richman QLD regarding the Mines inspection on the 9<sup>th</sup> of May 2019. During the inspection, it was found that a generator had been damaged in an incident and required repairs and inspection by an electrical contractor, MP948 had an emergency stop that was broken and needed replacing, MP940 and MP963 had lanyards that were broken or not working.

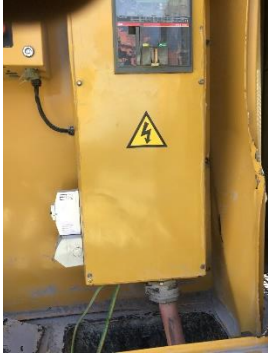
<p>Replace the damage enclosure</p>

<p>Repairs to switchboard and gland plat fitted on Generator</p>

<p>Replacement of glass in door of Generator.</p>
---	--	---

Parkers Electrical NQ arrived on site at around 11am on Friday the 10<sup>th</sup> of May 2019 to make repairs to a generator (GN814) that had been involved in an incident involving a loader and damage was caused to the generator. On inspection there was damage to the casing and door of the generator that prevented the door from closing and the glass panel was knocked out of the door, repairs were made to the door and the glass was reinstalled. The generator was electrically inspected and all electrical components were tested, the test results were within specifications. Enclosure with circuit breaker on the generator was replaced as there was a crack in the enclosure. The plant (MP904) was reconnected to the generator with the gland plate installed and further tests were conducted on the plant and generator, these results were also within specifications. We then reinstalled the front panel of the main switchboard on the generator and sealed from dust ingress. The plant and generator were then tested and ran, everything worked correctly.
